# Relation between surface temperature and dryer operation

I. VITÁZEK, J. TIROL

*Faculty of Engineering, Slovak University of Agriculture in Nitra, Nitra, Slovak Republic*

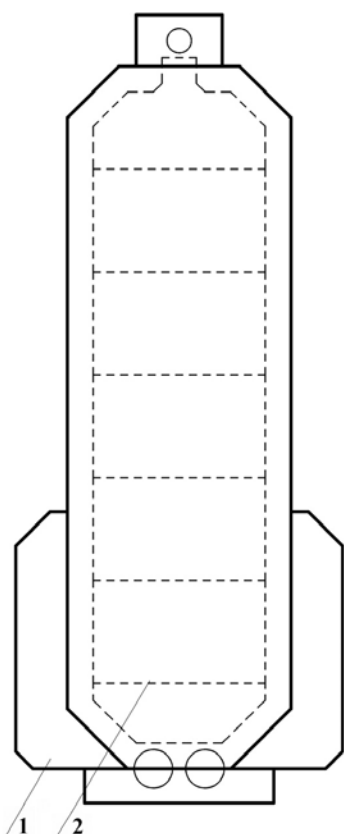
Figure 1. Design of MC 3180 dryer  
1 – recirculation, 2 – individual sections

The MC 3180 is a continuous flow shaft dryer divided horizontally into six drying sections and one cooling section, which may be altered to a drying section (Figure 1). A Venturi burner with a separate fan is located in each section. This means that the drying medium consists of a mixture of flue gases (of natural gas) and ambient air. The mentioned struc-

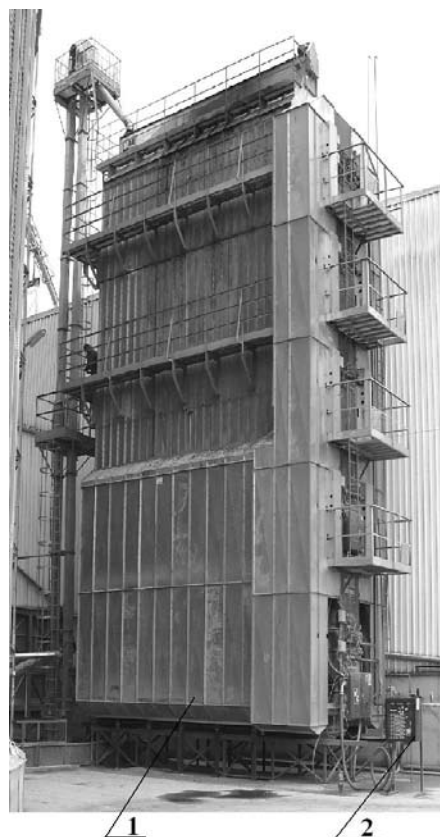
Figure 2. View of the examined MC 3180 dryer  
1 – metal plating for recirculation, 2 – controlling console

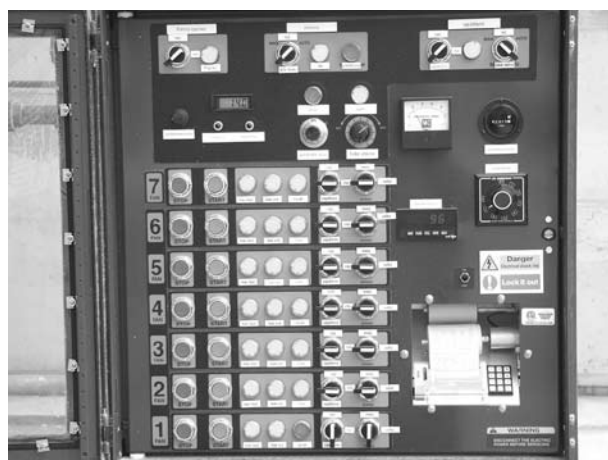
Figure 3. Controlling console of the dryer  
1–7 – regulation of fans and burners

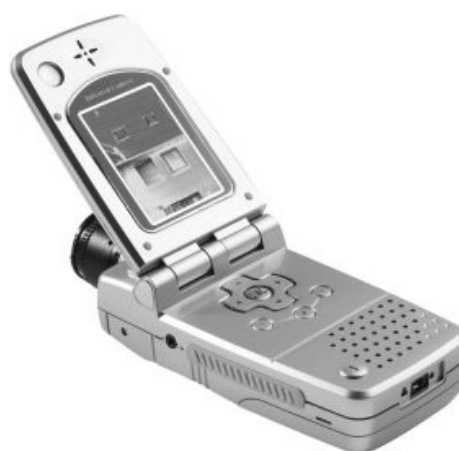
Figure 4. Thermo-camera micronix mobIR M3

The method of the check measurement was adapted for the continuous mode of the dryer operation. It was not a check measurement in terms of STN 12 6013 (1995) technical standard. The thermovision method was used for measuring the surface temperature at stable-state operation of the dryer. Thermo-camera micronix mobIR M3 (Figure 4) enables making thermovision shots which allows for a quick and precise measurement of the temperatures on the dryer casing. The camera measures temperatures in the range from  $-20^{\circ}\text{C}$  to  $+250^{\circ}\text{C}$  with accuracy of 2%. The resolution of the scanning chip is  $160 \times 120$  pixels. The camera display can be used right on the spot to determine the temperatures. The camera can be connected to PC through USB 1.1 interface, the photographs can be downloaded to the computer, and precise data can be evaluated using a software. Thermocamera mobIR has a built-in memory for storing up to 100 images. The advantage of this camera resides in its small size and weight.

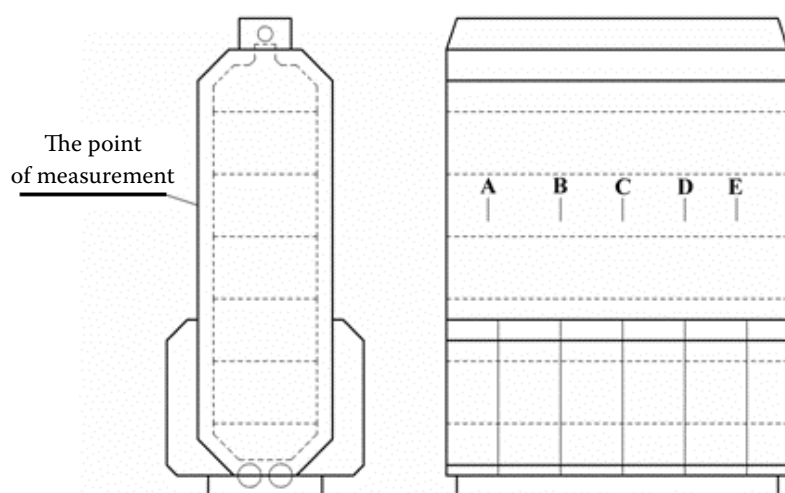
Figure 5. Diagram of the dryer with the points of measurement marked

In selected time intervals, we recorded the parameters of ambient air ( $t_0$ ,  $\phi_0$ ), temperature of the drying medium at its entry to the layer of the material  $t_1$ , and the parameters of the drying medium at the outlet from the dryer at selected points (Figure 5) of the outer casing ( $t_2$ ,  $\phi_2$ ). We analysed the parameters of the drying medium through displaying them on the i-x diagram of wet air. We used the i-x diagram of wet air of up to  $200^{\circ}\text{C}$  (CHYSKÝ 1977; VITÁZEK 2005) containing mixing lines for natural gas (Figure 8). Point 0 represents the state of the ambient air; point 1 represents the state of the drying medium at its entry to the layer of the dried material.

The average values of the drying medium parameters measured at the points shown in the diagram in Figure 5 are presented in Table 1.

As the measured data suggest, the temperature and humidity of the drying medium at the outlet from the dryer varied depending on the point of measurement (A to E). However, in each given point of measurement, they did not change significantly, which means that the dryer was operated in a stable state. Significant differences exist between points A, B, and E on one side, and points C and D on the other side. In the first case (A, B, E), clearly higher temperatures and lower relative humidities of the drying medium were found, while in the second case (C, D) vice versa.

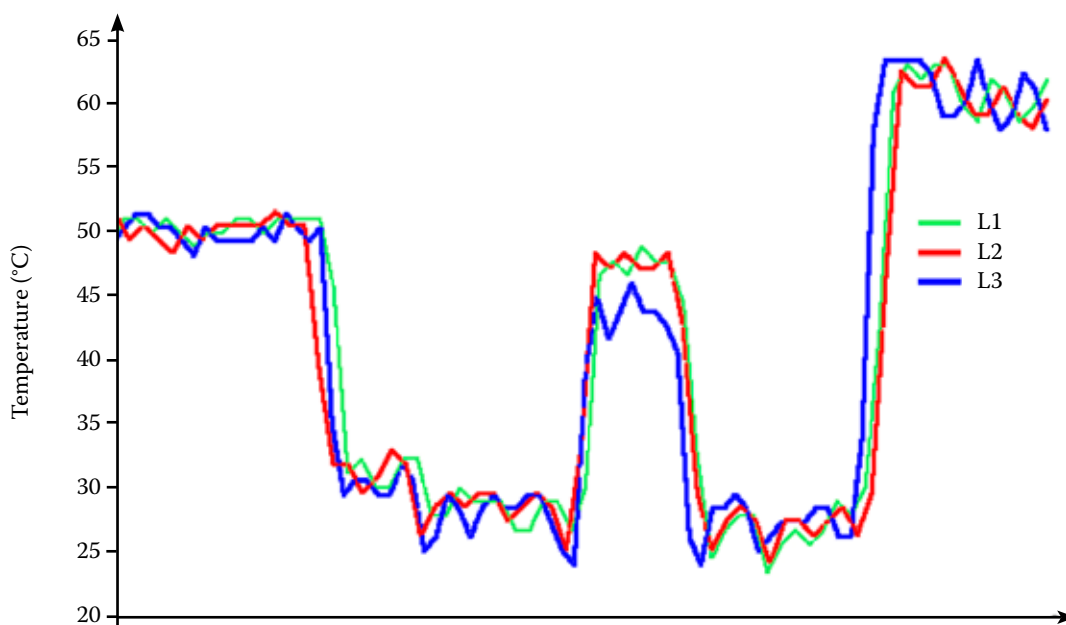
Figure 7. Time course of temperatures at selected points according to Figure 6

Figure 6 shows the thermovision camera shots of the examined dryer, with lines L1 to L3 marking the points of measurement at times 10.20, 10.50 and 11.50 h, as done by the manual measurement (results in Table 1). The courses of temperatures at points L1 to L3 are shown in Figure 7 using the provided

software. Equally, even on the basis of these data, we can suppose that the dryer was operated in a stable state.

Comparing the data from Table 1 with the data of the temperature course from Figure 7, we can state the following:

- The courses of temperature are mutually related according to the point of measurement (A to E).
- The cause for the dryer casing temperature drop (two significant drops – Figure 7) lies in silting up of the outer perforated casing, which results in reduced sizes of the openings or even their total congestion. These are the obvious dark spots in the thermovision camera shots (Figure 6). For this reason, the drying medium flows through the given places at a lower speed, thus cooling off more and becoming more moist at the same time. Reducing the air flow through these places

of the dryer, however, increases the drying medium flow at the places not silted up, which is shown through its higher temperature and lower relative humidity (places A, B and E).

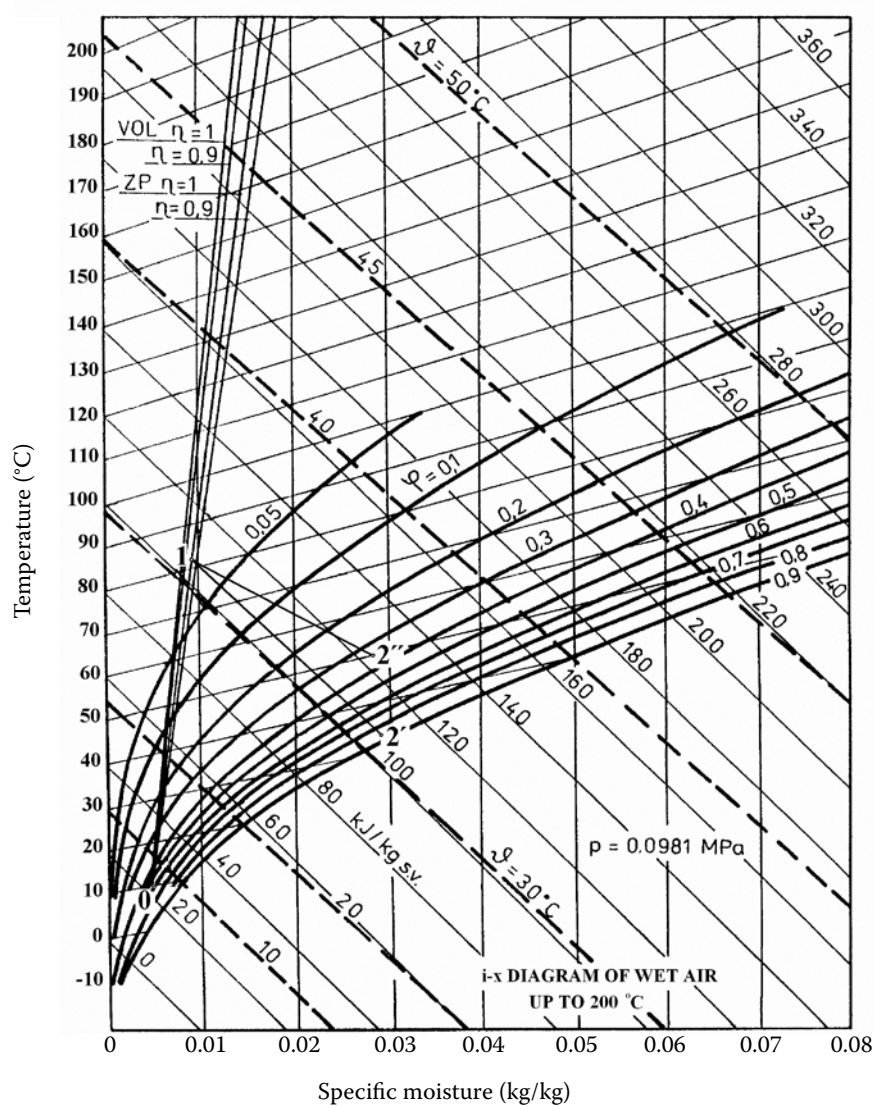
Figure 8. Course of state changes of the drying medium in i-x diagram of wet air

The selected measured states of the drying medium are drawn into i-x diagram of wet air of up to 200°C containing mixing lines of the fuel used. The

state of the drying medium denoted 2' represents still an almost standard course. State denoted 2'' already represents a course atypical for hot-air drying. Although the humidity of the drying medium increased and its temperature decreased, its enthalpy increased.

The illustration of the way of the drying medium state change in i-x diagram of wet air allows for the

assessment of the drying process itself, utilisation of the added energy, and thereby the exploitation of the drying power of heated air (VITÁZEK 2006). In the given case, it depicts an extreme situation when the drying medium is indeed being saturated with moisture, but its enthalpy is rising at the same time.
